Halifax Park / Fly Point Sand Accumulation Study

R.N2128.001.01.docx
September 2011

Prepared For: Port Stephens - Great Lakes Marine Park

Prepared By: BMT WBM Pty Ltd (Member of the BMT group of companies)

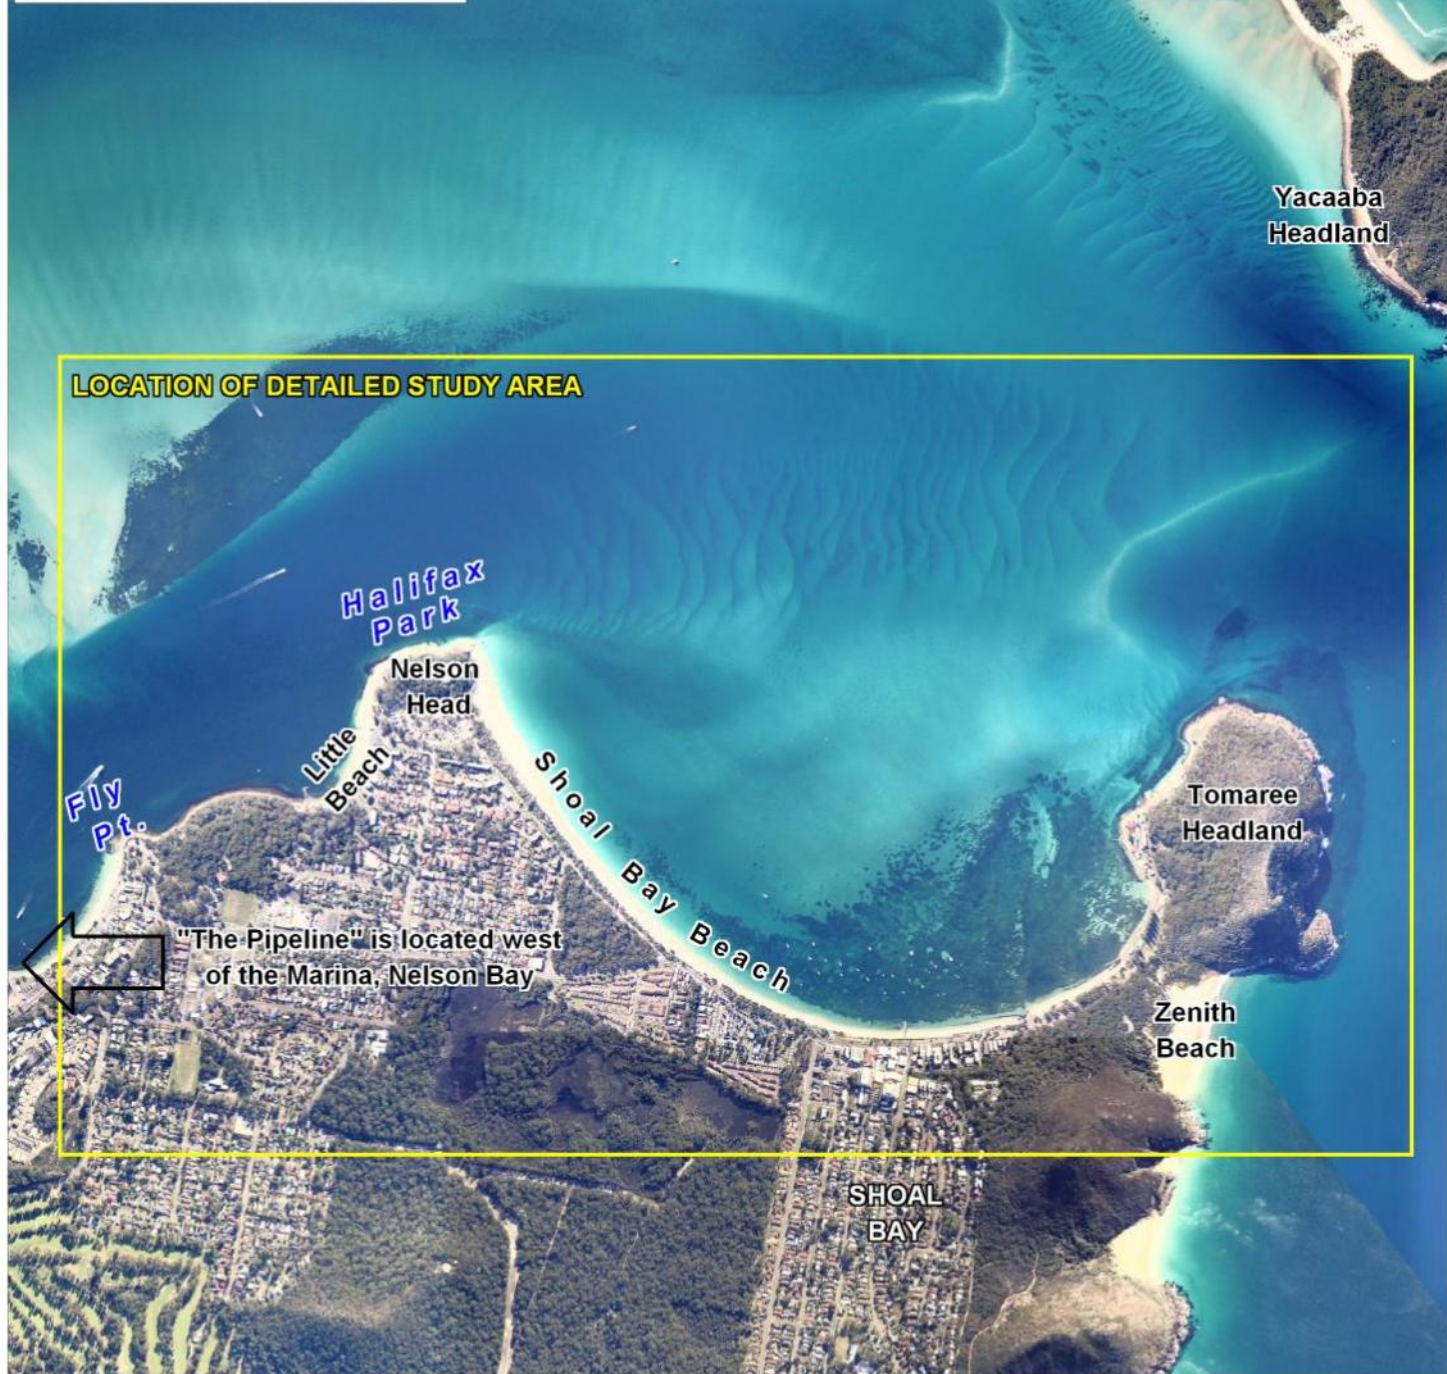
Figure:
1-1

Title:
Study Area

A locality plan showing the area of concern is provided as Figure 1-1.

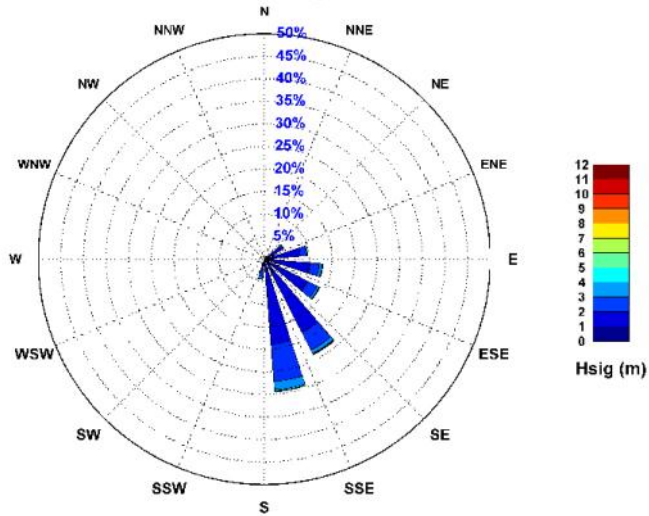
Figure:
2-5

Title:
Seasonal Offshore Wave Climate for Sydney (Hs)

The seasonal climate from each of the last 5 years was also examined. This analysis found that during winter and spring of 2010 and the summer of 2010/2011 the wave climate tended towards more easterly waves when compared to the long term averages. This pattern is expected, following a transition from negative to positive SOI (el-Niño to la-Niña) (Ranasinghe *et al.*, 2004), as occurred during the first half of 2010. The slight change in wave climate is also of some importance when considering exposure of the western end of Shoal Bay to swell waves.

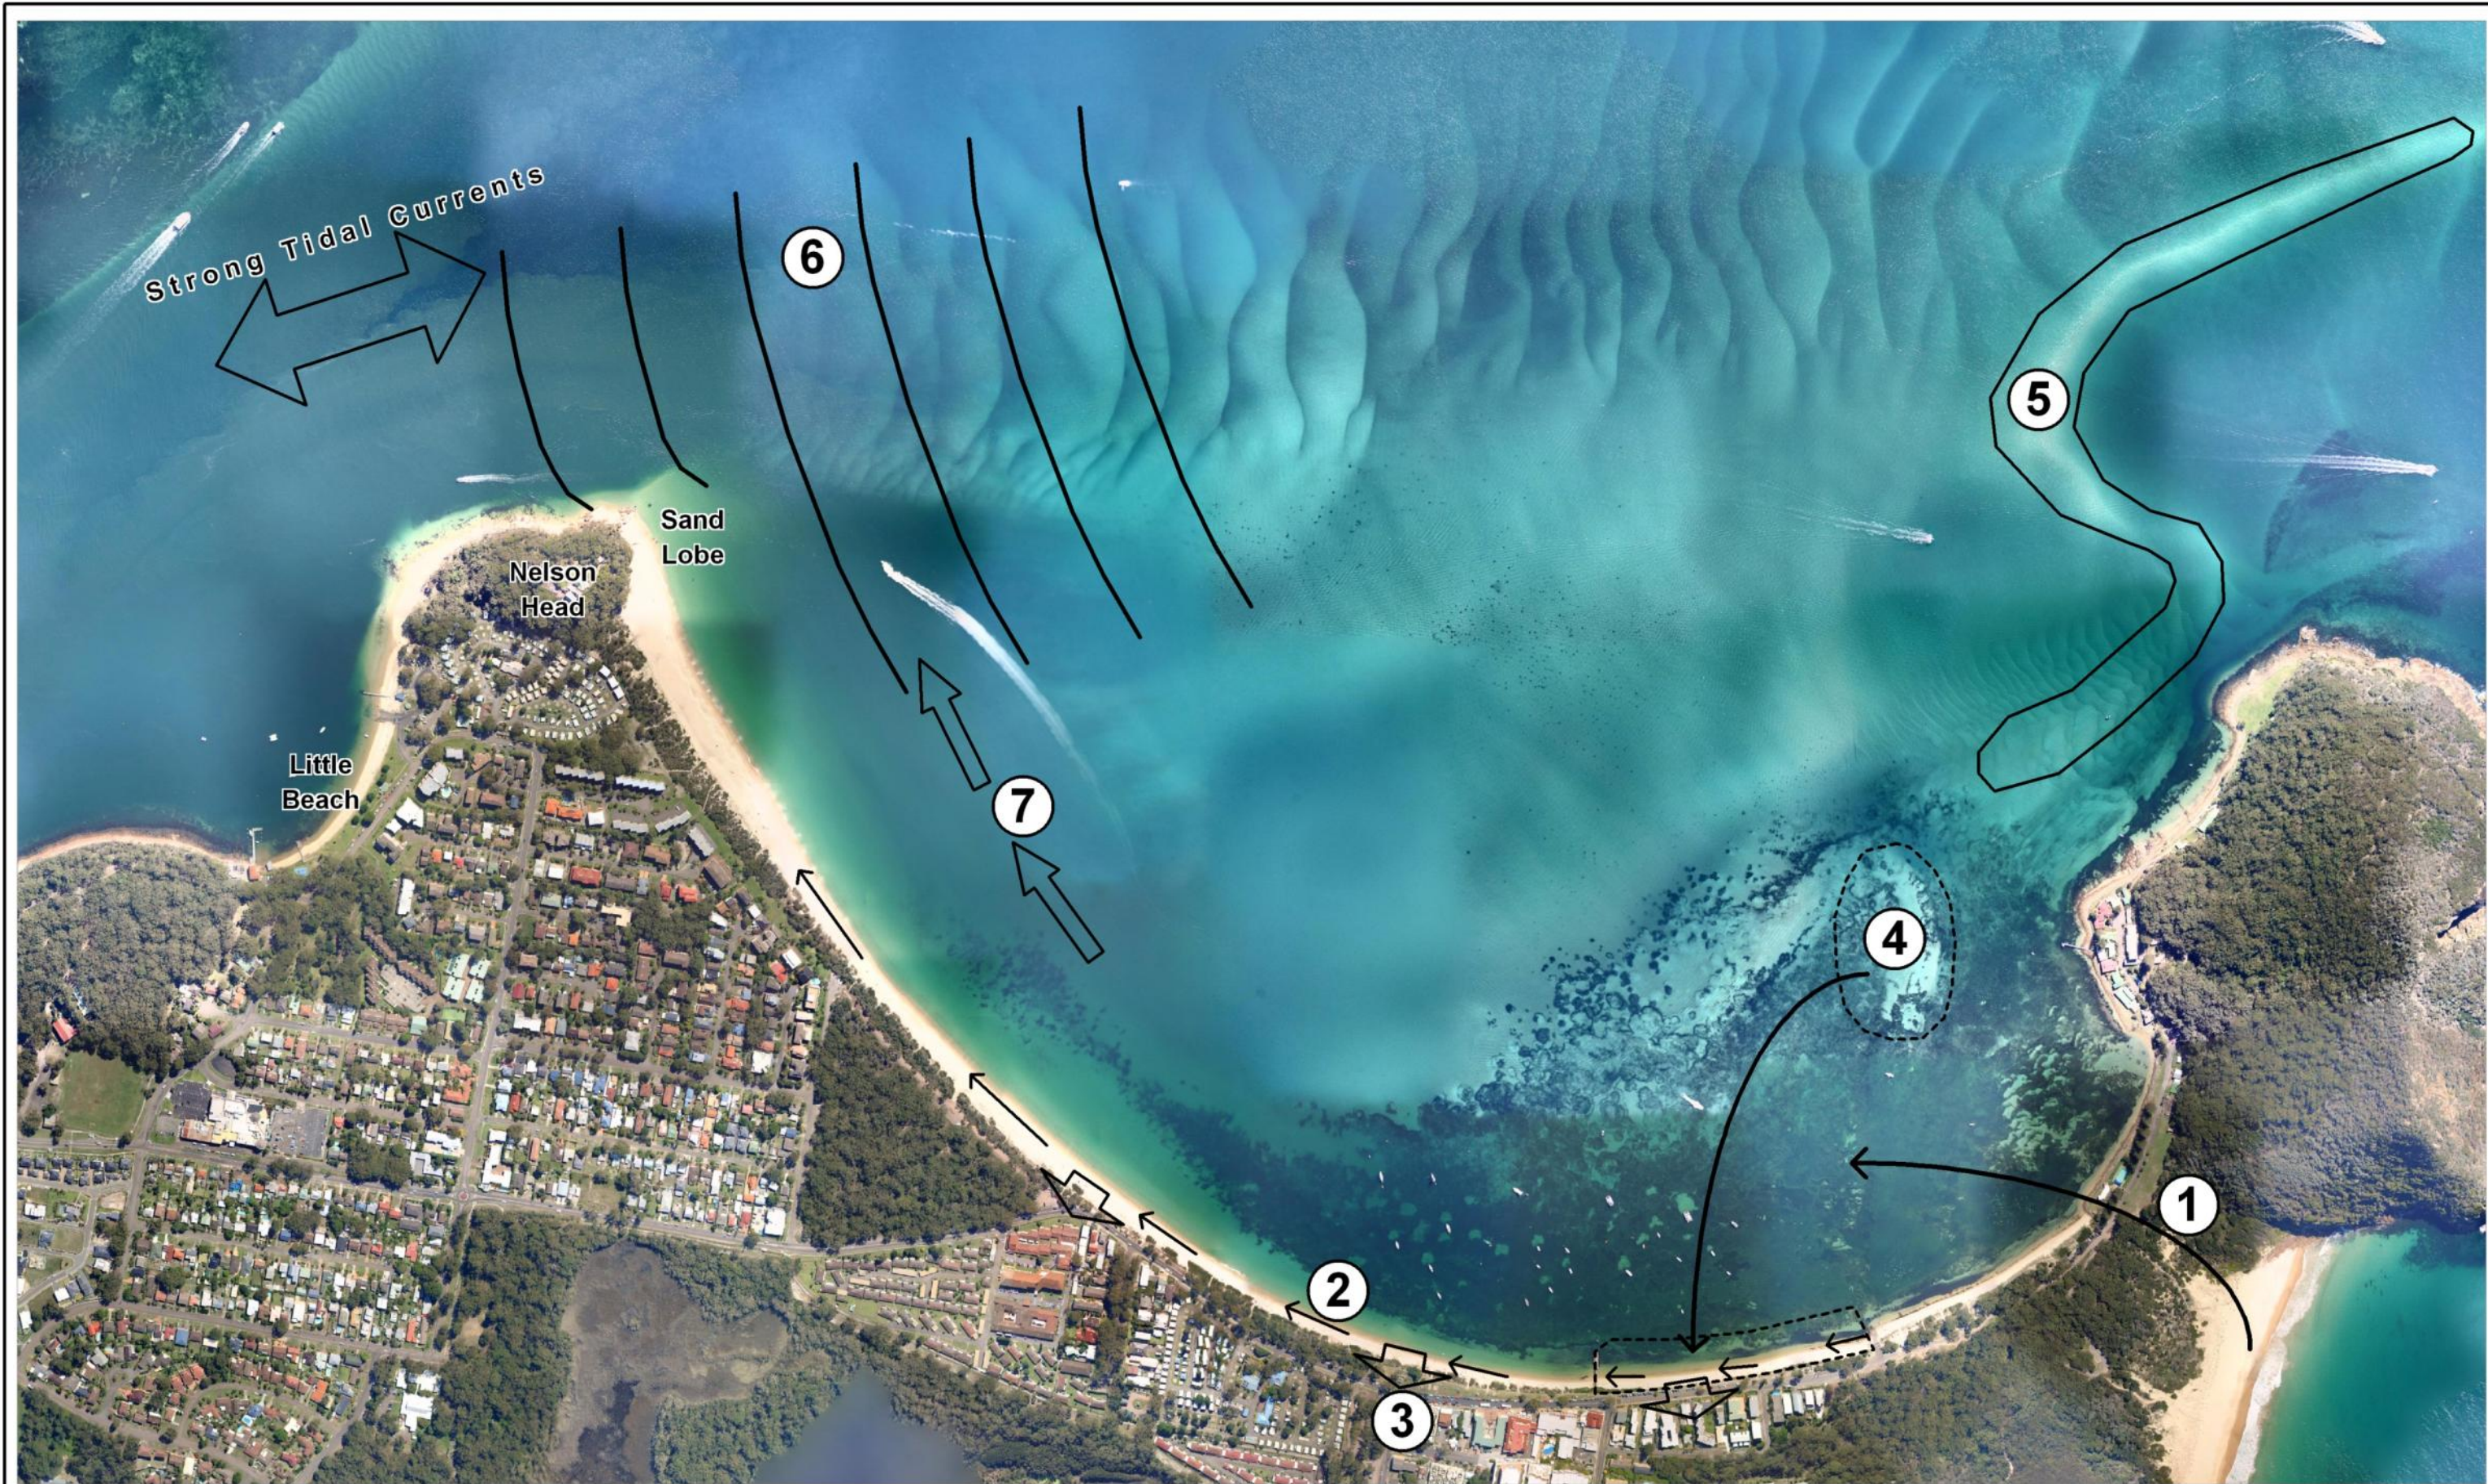
Figure:
2-8

ID	Description
Figure 2.8	
1	Prior to the 1960's sand from Zenith Beach contributed to the overall sand budget of Shoal Bay. This supply has subsequently stopped through progressive vegetation of the dune between 1960 and 1990.
2	Numerous researchers have found that the dominant direction of sand transport along the Shoal Bay shoreline is from east to west
3	While the entire length of Shoal Bay has receded over the past 40-50 years, effects at the eastern end have been most severe, partly due to the proximity of development and the presence of assets such as the boat

9	Sand bypasses the headland within the upper shoreface. The rate of sand bypassing is variable, as indicated by the residual sand on the northern shoreline of Nelson Head, which ranges from effectively nothing (late 1990s / early 2000s) to a broad sandy beach (re-established since about 2008). As sand is transported along the upper shoreface, some is likely to slump down the steep edge, through the Halifax Park sponge gardens and into the deeper tidal channel. This sand is likely to be carried away quickly by the swift tidal currents in this area.
10	As sand is pushed into the tidal channel, either off the sand lobe or down the steep slope from the upper shoreface, it is transported by swift tidal currents to form ebb tide and flood tide sand splays, with deposition occurring where current speeds decrease. The flood-tide splay could extend some distance westward, and may be contributing to increases in the size of sand dunes offshore of Fly Point, although this process requires further investigation.

11	Refracted swell waves strike the shoreline of Halifax Park obliquely, helping to transport sand from east to west. A proportion of the sand moving along the upper shoreface will slump into deeper waters due to over-steepening of the bed profile.
12	A second lobe of sand has accumulated at this location, resulting from continued supply of sand along the northern Nelson Head shoreline. Port Stephens Council removed sand from this area in late 2010.
13	Wind waves originating from the north-east to north-west and refracted swell waves coming around Nelson Head impact on the shoreline at Little Beach obliquely, causing on-going transport of sand southwards towards the boat ramp where it can interfere with boat launching activities.

Title:
Conceptual Model of Sand Movement

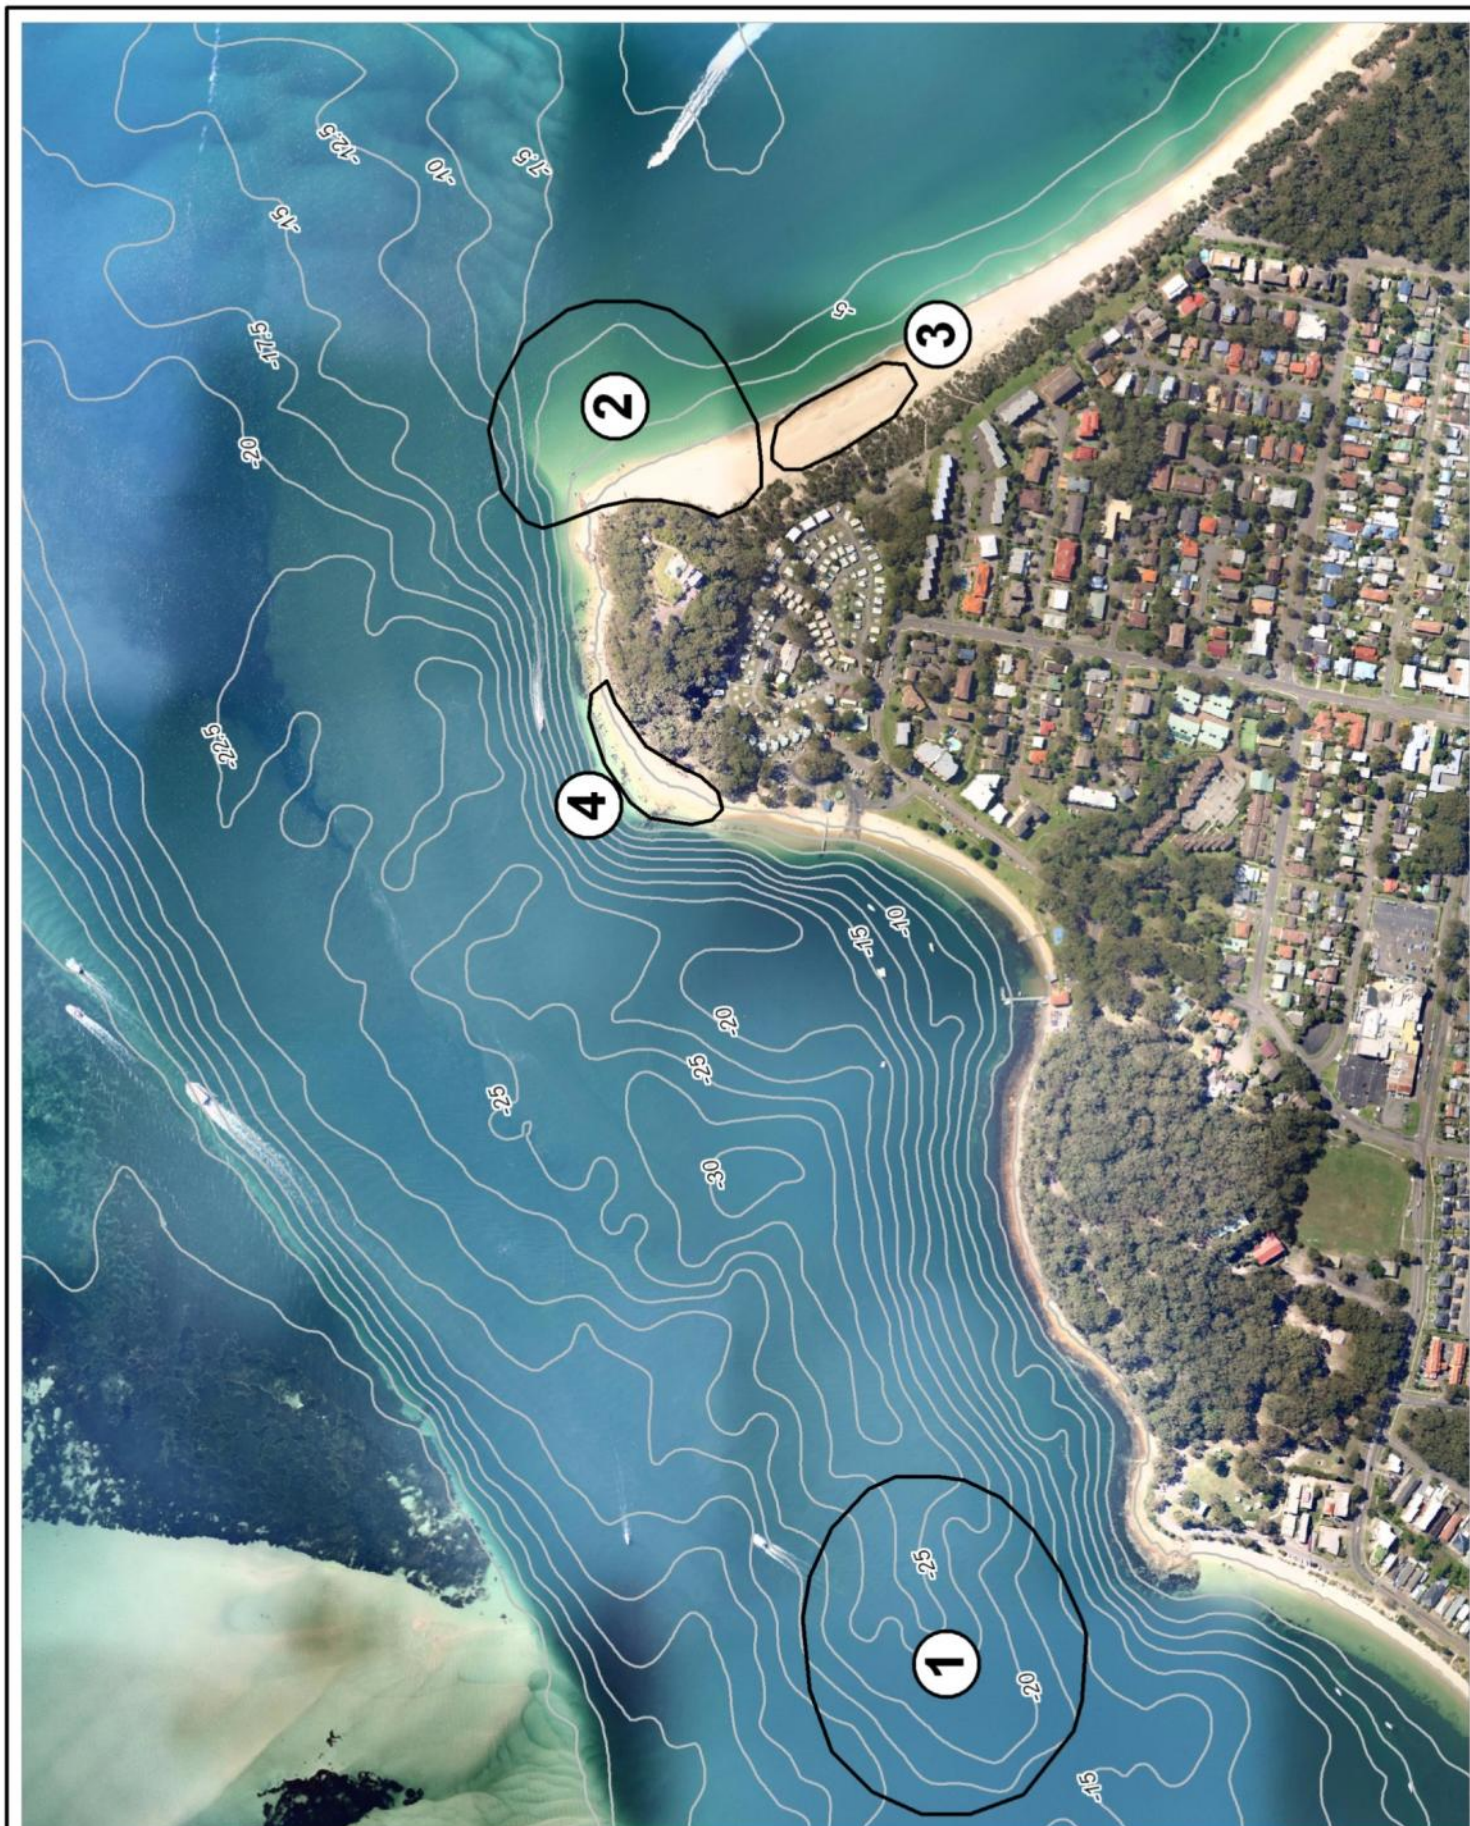
Figure:
3.1

Title:
Priority Areas for Removal

5. Sub-aerial Little Beach: This area is a lower priority in terms of protecting dive sites. The area was cleared during November 2010 and the main reason for dredging in this area is to protect operation of the boat ramp.
6. Sub aqueous slope, Halifax Park: Evidence suggests the natural clearing of sand in this area by tides, providing any new sand supply is limited. Given the likely expense of delicate sand removal operations that would need to be employed, monitoring this area to assess its response to removal from other initiatives is recommended in the first instance.
7. Deep Channel North of Nelson Head: Again, it is considered likely that tidal currents will assist in clearing this area, if sand accumulation is problematic, and recommend monitoring as a suitable initial option.
